# Humidity problem solved at Illinois State Archives

## CASE STUDY: Illinois State Archives

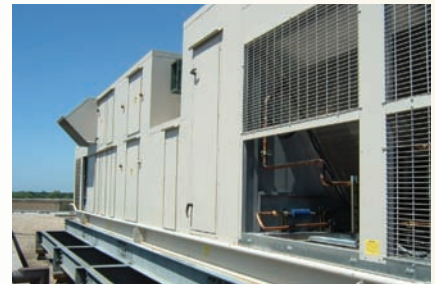
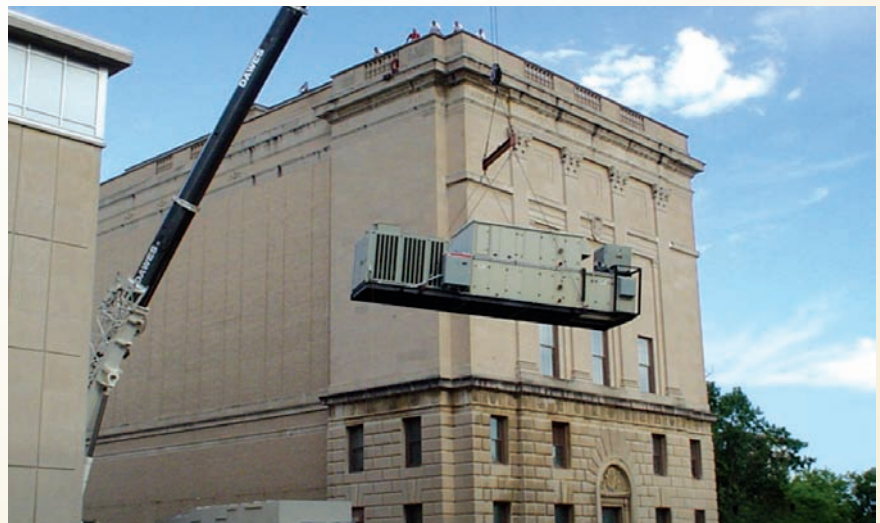
(Above) A crane removes the old dehumidification equipment from the building rooftop. (Top Right) A more efficient and effective Munters humidity control system was installed.

The customized Munters dehumidifier uses conventional refrigerant driven air conditioning coils to precool 100% outside air prior to its passing through the desiccant wheel to remove the excess moisture. The air then passes through a post cool DX system that brings it to a neutral 62°F and releases it into the building where the floor-by-floor air-handling units condition and circulate it.

In the winter, heating coils in the unit using low pressure steam preheat the dehumidified air to the same temperature before releasing it in the building. In the sealed vaults, their air handlers maintain temperatures at the desired 65°F dry bulb and 40°F relative humidity. Dehumidifying all that outside air was where the Munters engineers made the difference.
